Fuel Leak – Night Mission

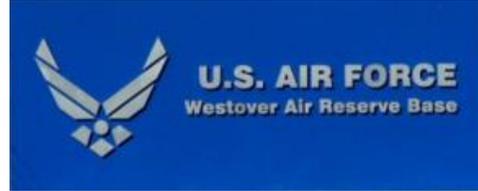
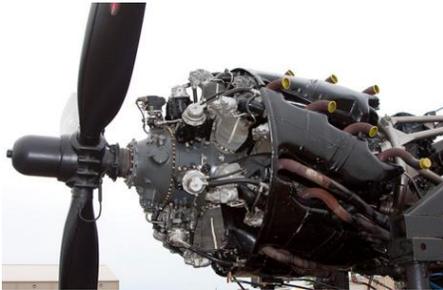
Sometime in the mid to late 70's (probably 1977) Westover had an in flight engine fire on one of their C-123's. The aircraft had experienced #1 engine power loss on previous flight with an undetermined cause. The incident aircraft was being flown on a test hop to further troubleshoot the engine malfunction. During the test hop the number one engine again experienced the malfunction but this time with an uncontrollable engine fire. Luckily the aircraft was recovered at Westover only due to the airmanship of an experienced crew. As a side note, the flight mechanic bailed out of the aircraft due to the intensity of the fire coming into the cargo compartment.

The accident team determined that the root cause of the fire was a ruptured main fuel hose to the number one reciprocating engine. As a result all C-123's were grounded until all liquid carrying lines on the aircraft were replaced. As one can imagine this was a large and somewhat complex task.

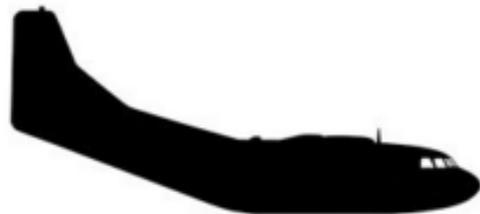
Shortly after takeoff I started the require wing / engine check. As soon as I came off the step box I smelled STRONG fuel fumes. As most former C-123 crew members remember the fuel fumes traveled from the nacelle through the wing roots. That was the most common place to detect the fumes.

I shined my flashlight on the right nacelle and saw **fuel** coming out of the number two recip inboard pork chop panel. It was right in the inboard exhaust flame path and to this day I don't understand why it didn't torch.

I knew that the only remaining fuel source in the nacelle area was for the aircraft heaters. As soon as the pilot shut down the heaters the fuel leak stopped. We landed and evacuated the aircraft on the runway. After the aircraft was towed off the runway we took off the pork chop panel and discovered that the heater fuel supply line was the cause of the leak.

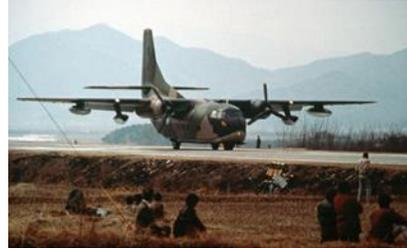
I immediately called the pilot on interphone and requested that they shut down the right recip. They did but to my amazement the fuel leak didn't even slow down. (as a side note the nacelle fuel tank recip and jet quick disconnects were side by side in that area.

The drop tank QD was on the other side of the nacelle tank). I then requested that the pilot shut down the right jet. Surprisingly the fuel leak still didn't slow down. The drop tanks hadn't been pressurized yet so the fuel couldn't have been coming from the right tank QD. Luckily I had previously been on a maintenance crew that performed one of the hose replacements and was familiar with the fuel plumbing in the nacelle area.
